NATIONAL DAM SAFETY PROGRAM, NEW VIBURNUM TAILINGS DAM (MO 3123--ETC(U)

NEW VIBURNUM TAILINGS DAM
IRON COUNTY, MISSOURI
MO 31231

PHASE 1 INSPECTION REPORT NATIONAL DAM SAFETY INSPECTION

APRIL 1981

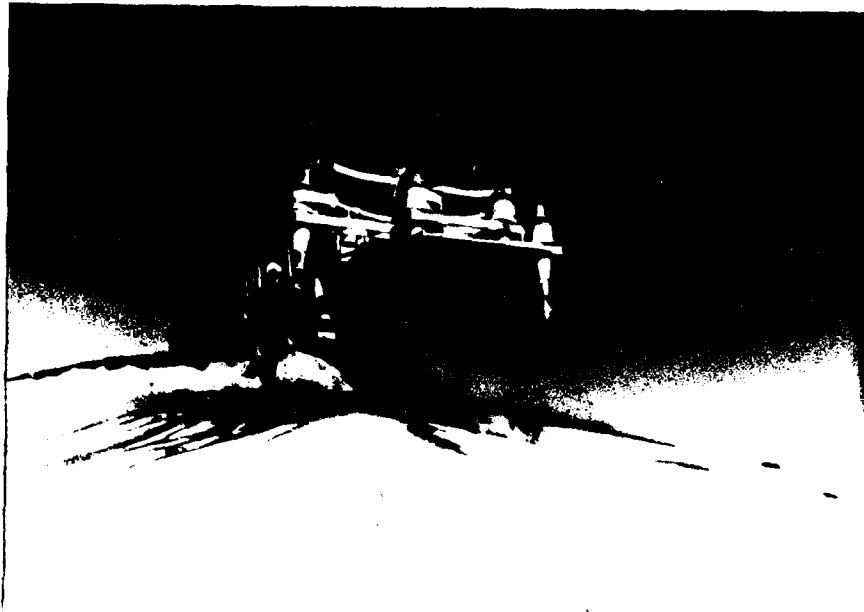
3. Cyclone installed on the crest of the embankment spreading slurries of the coarse-grained fraction used for the construction of the embankment.

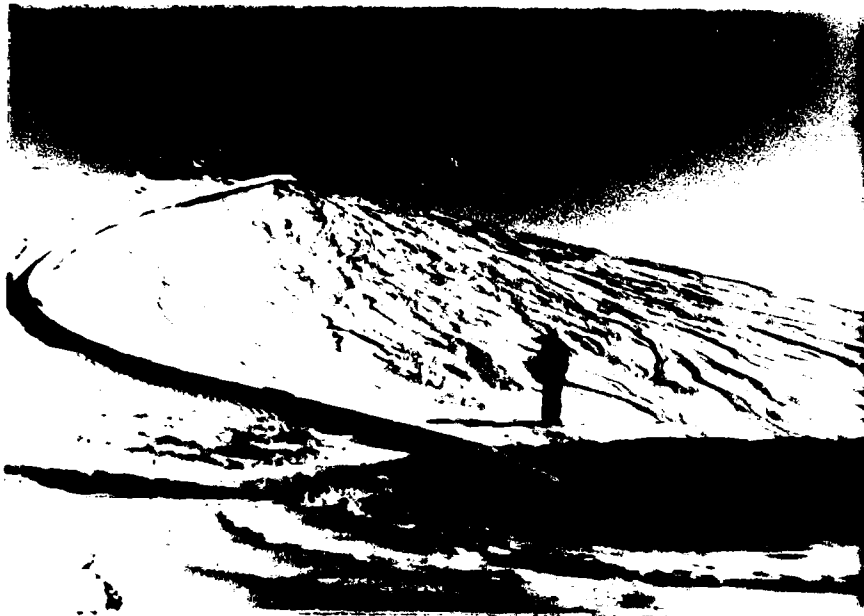
4. Discharge pipe from the cyclone along the upstream face of the embankment.

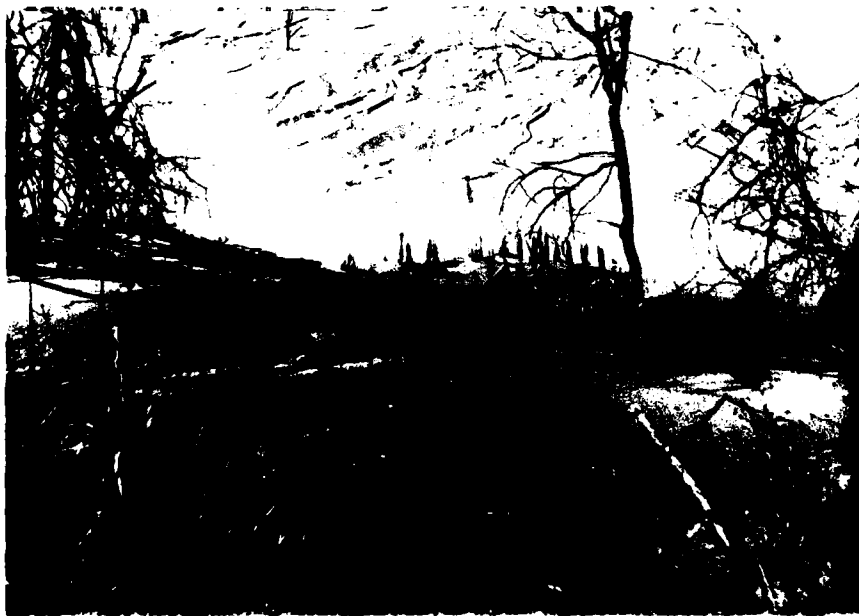
Clear water at a rate of approximately 125 gal/min is discharging from a 12-in. diameter drain pipe near the toe of the dam (Photo 9). Clear seepage of about 20 gal/min is also discharging from the toe near the left abutment (Photo 10). It was noticed during our inspection that the area at the toe of the dam was wet and rather soft and showed signs of limited slumping. However, no signs of internal erosion were observed. The extent of these seepage phenomena could not be evaluated accurately, but it was thought that all the water accumulated in the drain downstream of the starter dam was not flowing through the 12-in. diameter pipe but that some water seeped through the embankment toe. The exposed portion of the upstream slope is at an inclination of about 5(H) to 1(V). The downstream slope is also at an inclination of about 5(H) to 1(V).

10. Seepage at the toe of the downstream face of the embankment near the left abutment.
